TAW CATCHMENT – GRAVEL CLEANING, 2019

Fisheries Improvement Management

Westcountry Rivers Trust
Report written by Mia Bryant, Fisheries Officer
Contributions by Adrian Dowding, Devon River & Fisheries Manager
Funded by River Taw Fisheries Association

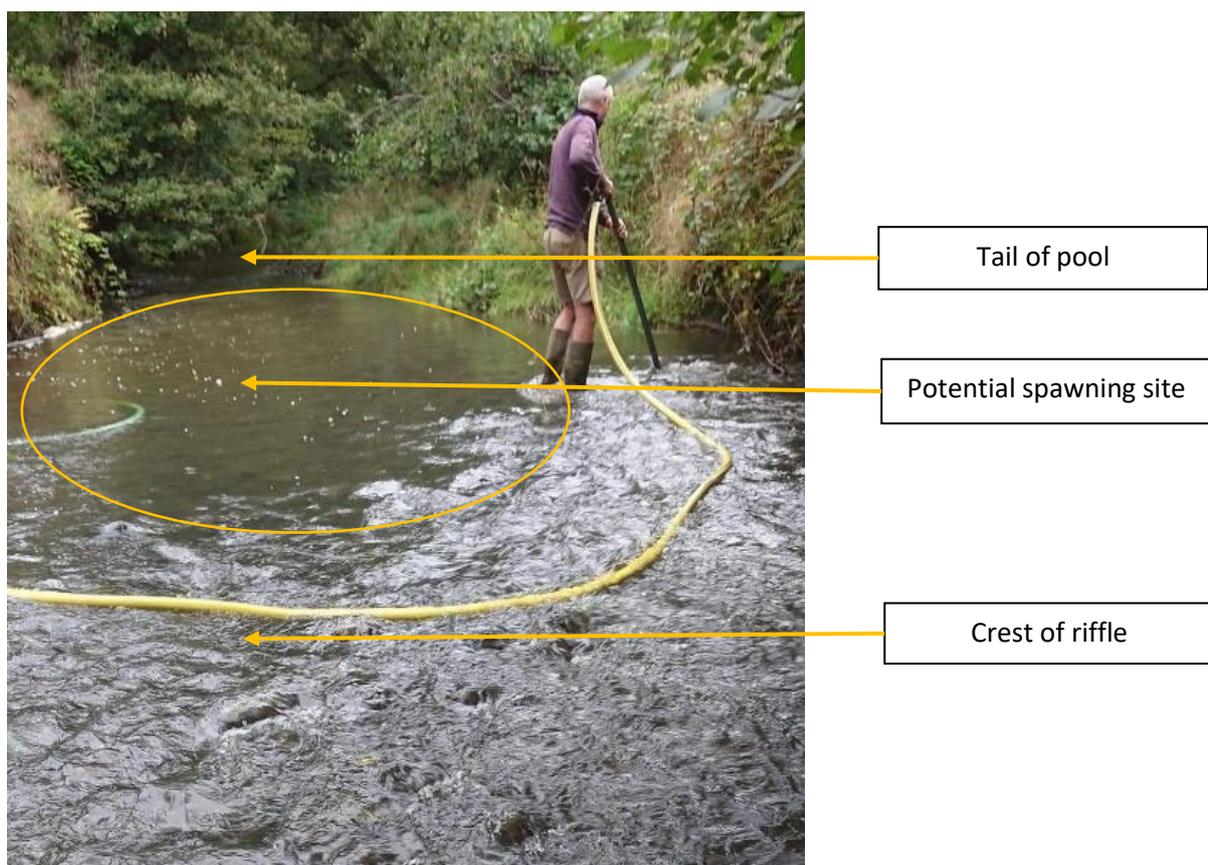
Figure 1 Spawning site selection example

Presence of pool-riffle sequences are critical for salmon redd site selection. Particularly at the tail of pools, which is also positioned at the crest of a riffle, whereby water can through-flow into the gravels and support other crucial requirements for salmonids in their egg-larval stages providing a steady flow of cool, oxygenated water (*Bjornn and Reiser, 2002*). An example of a site selected is illustrated (Figure 1);

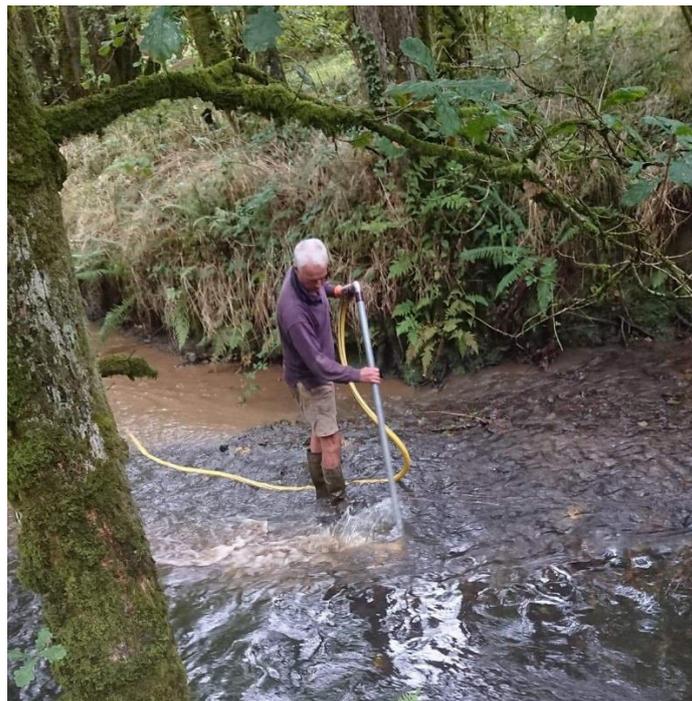
Figure 2: Sediment release from riverbed

Starting upstream and working down river of the referenced reach (from provided landowner permissions). Operatives worked along the stretch and cleaned spawning gravel sites in accordance with good practice guidelines using a water pump method, whereby pressurised water cleans the gravels approximately 4-5 inches into the riverbed. See in Figure 2, the discoloration from the level of sediment behind the operator where the riffle drops off into a pool. As the operative flushes the sediment from the riffle/spawning habitat, the sediment drops downstream with the flow and settles in pools and eddies where the sediment is not in highly sensitive habitat zones.

The objective of this activity is to break up any compaction of the gravel and to remove as much of the accumulated silt as possible, in order to allow better throughflow of well oxygenated river water, to increase successful salmon and trout spawning, egg survival and fry recruitment activity.

Upon identifying the site of suited salmonid spawning gravels – operatives used a standard 50mm water pump that was mounted to the back of a quadbike in order to allow easy access to riverbank sites. The inlet to the pump uses the river water from one end of the hose and forces water to the outlet from the pump, which is connected to a hand-held lance made from a metal pipe which is throttled down to 10mm to achieve adequate pressure.
